**Riverstone Networks Switch Router  
System Firmware Version 8.0.3.13  
October 2003**

This document provides specific information for version 8.0.3.13 and 8.0.3.13L of the system firmware for the Riverstone Networks RS Switch Router family of products.

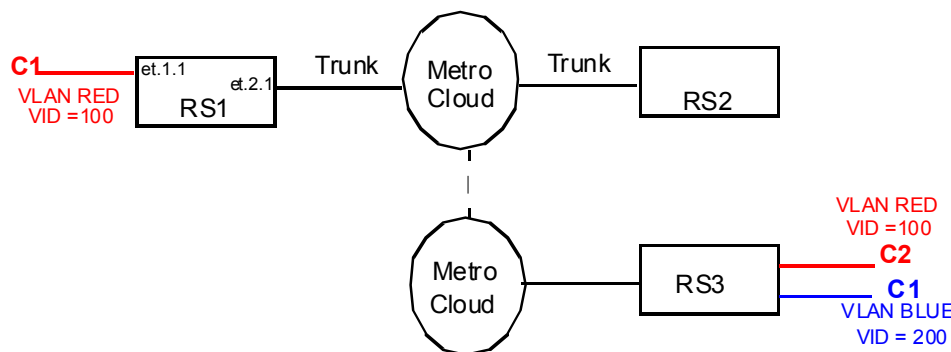
In the following diagram, the metro provider assigned Customer 1 (C1) to VLAN RED (VID = 100) on RS1 and to VLAN BLUE (VID = 200) on RS3. The metro provider previously assigned Customer 2 (C2) to VLAN RED on RS3.

The two metro clouds are then connected, resulting in the provider having two different customers (C1 and C2) with the same VID on the same MAN. The metro provider could reassign the VIDs so they do not overlap. But this would require the customers to change their configurations. The more efficient alternative is to configure a VLAN translation filter and apply it to port et.1.1 on RS1.

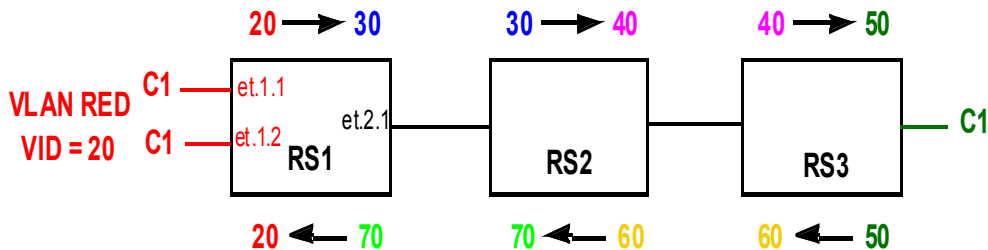
In the following example, the VIDs are treated similar to MPLS transport labels. On RS1, ports et.1.1 and et.1.2 belong to VLAN RED, which has a VID of 20. The VID of incoming frames on these ports is translated from 20 to 30, while the VID of the reverse traffic coming in on port et.2.1 is translated from 70 to 20.

In the example, a different VLAN translation filter is applied to each direction of traffic; traffic flowing in one direction uses a VLAN translation scheme that is different from the one used in the reverse direction. Following is the configuration for RS1:

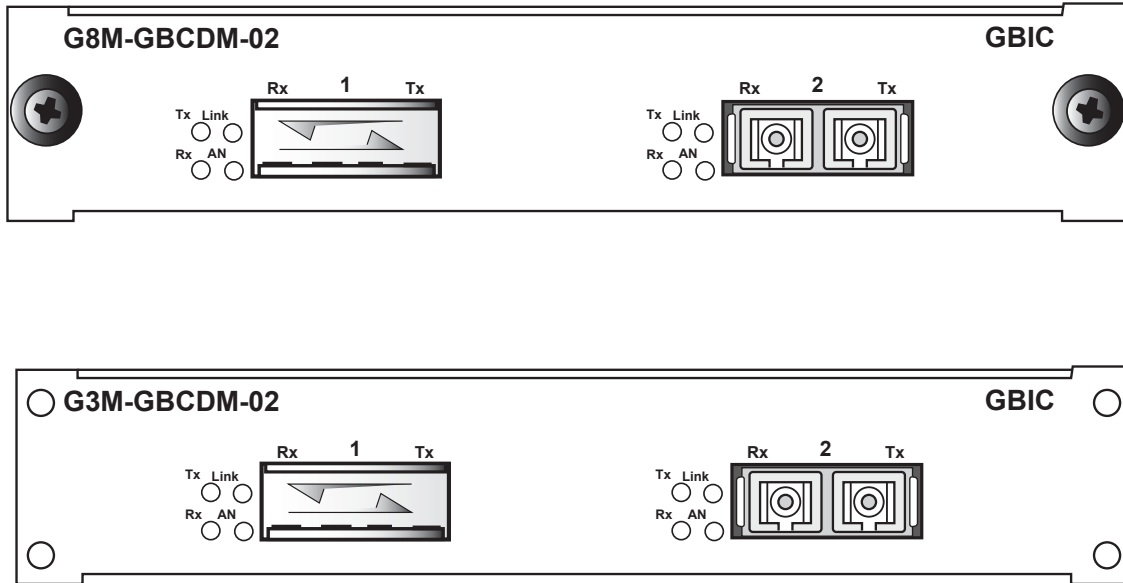
The following figure shows the front panels of the 2-port non-MPLS activated Gigabit Interface Converter (GBIC) line cards. The G8M-GBCDM-02 is used with the RS 8000 and RS 8600 switch routers. The G3M-GBCDM-02 is used with the RS 3000 and RS 1000 switch routers.

Front panels of the Gigabit GBIC line cards with one GBIC installed
